## Real-World Explosions and Fire Examples by Dr. John Nordin

We will take a snapshot look at example explosions and fires involving chemicals including fuels. Many of the examples chosen occurred at U.S. industrial facilities. Major accidents at these locations are investigated by governmental agencies such as the Chemical Safety Board, the Department of Transportation, Occupational Safety and Health Administration, and the Environmental Protection Agency, and their reports are published and available in the public domain. Other investigations are done by insurance companies. Similar investigations are done by appropriate governmental agencies in several other countries, and the reports are sometimes available. Several of these events are vapor cloud explosions. Some involve tank or vessel explosions and some examples are cascading chain-event accidents. Both catastrophic and smaller scale examples are illustrated.

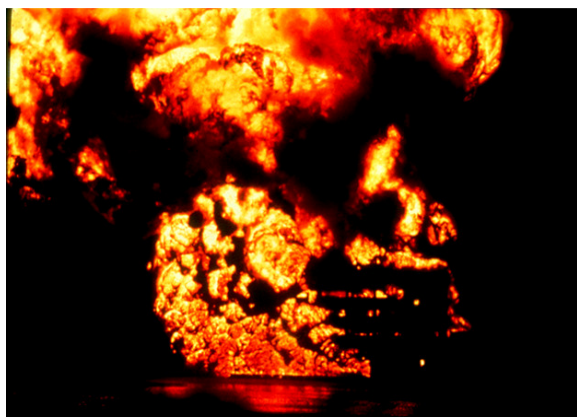
On 23 October 1989, at about 1 PM, a vapor cloud explosion and fireball occurred at the Phillips 66 Company polyethylene production plant near Pasadena, Texas, killing 23 workers, one worker missing, and injuring more than 130 others (one account said 314 people injured). The accident was investigated by Occupational Safety and Health Administration, the Environmental Protection Agency and other agencies; the OSHA report is available at <http://ncsp.tamu.edu/reports/phillips/first%20part.pdf> and a book on the incident is available through <http://catalogue.nla.gov.au/Record/4183313?&#details>.

The vapor cloud resulted as a sudden gas release of an estimated 85,000 lbs of a flammable gas mixture through an 8-inch open valve; the gas was a mixture of hydrogen, ethylene, hexane, and isobutylene. The accident apparently occurred when operators were trying to remove solidified polyethylene from the system. The vapor cloud (estimated to be roughly 1100 feet long, 800 feet wide, and 5 feet high) drifted downwind for about 90 to 120 seconds (another account said 5 minutes) before contacting an ignition source. The wind was from the south at 10 to 16 mph. The vapor cloud plus additional flammable gas inside tanks at the valve source exploded with a force equivalent to 2.4 tons of TNT based on blast damage. Two isobutene storage tanks exploded 10 to 15 minutes later. A third explosion occurred 15 to 30 minutes later when a polyethylene plant reactor failed catastrophically. The two polyethylene production plants covering 16 acres near the source of the blast were destroyed. Windows were shattered and bricks were ripped out in an administration building 0.5 miles away. Fragments were thrown as far as six miles away. The OSHA investigation uncovered a number of deficiencies resulting in fines against the petrochemical company and its operating contractor.

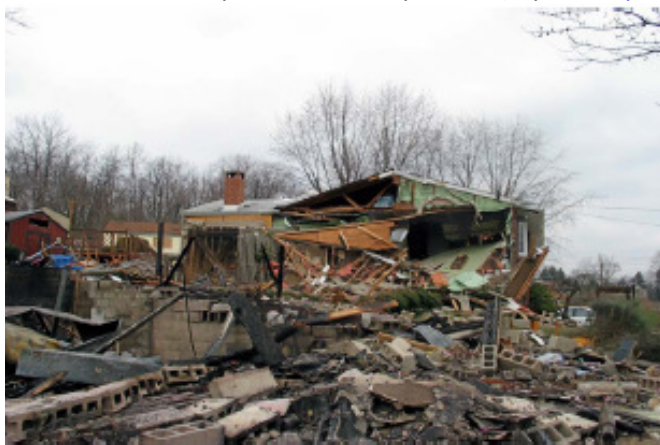
From National Transportation Safety Board Report DCA-08-FP-006

The cause of the explosion was a corroded and cracked 2-inch natural gas pipeline, at 10 psig, which failed resulting in natural gas entering the home via a porous backfill for a nearby sewer line from the house. All this occurred underground with no advanced warning. Apparently the home filled quickly with natural gas as no one in the neighborhood noticed the natural gas odorant. The concentration of natural gas reached the lower explosive limit, the gas found an ignition source, and the house exploded.

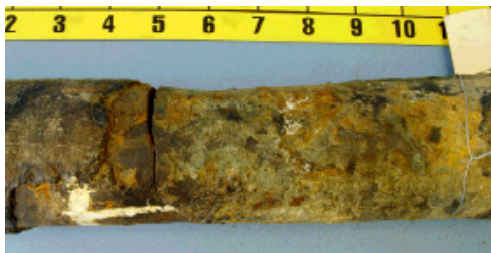
Cracked natural gas pipeline feeding house

The report concluded excavation 5 years earlier for a sewer line likely damaged the protective coating of the pipeline allowing corrosion and eventual pipe failure to occur. The pipeline itself was not affected by the house explosion.

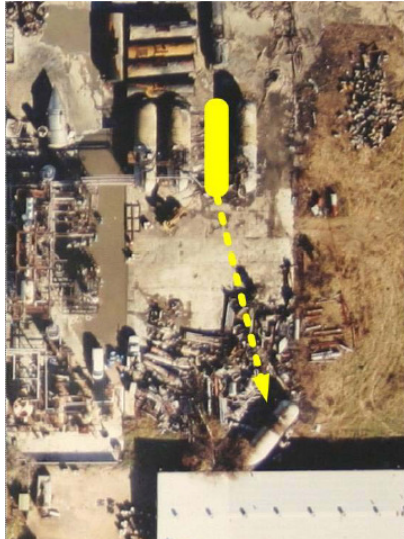
On 3 December 2004, a tank flash fire and explosion occurred at a processing facility operated by Marcus Oil and Chemical on the southwest side of Houston. The horizontal tank itself (12 foot in diameter and 50 foot long) was propelled 150 feet where it impacted a warehouse (see yellow arrow at left). The tank was part of a polyethylene wax processing operation, and normally operated at 300°F and under a mostly nitrogen atmosphere at about 45 psig. Later investigation by the U.S. Chemical Safety Board (CSB) showed that that tank likely failed due to a defective weld at a tank patch plate at possibly 69 psig, and that the nitrogen generator used to pressurize the system contained as much as 18% oxygen. A fire resulted which burned for 7 hours. The blast caused structural damage and glass breakage up to 0.25 miles away. A 120 pound steel plate was found in a pasture 900 feet away. A 2-pound steel plate was found in the yard of a resident ¼ mile away. The full report is available at

Normally, the wax-like material inside the tank was not considered flammable but is combustible. The CBS report concluded that at about 69 psig, the defective weld failed severing a tank patch plate from the tank. When the patch plate struck the concrete pad, sparks were generated which ignited the wax and hydrocarbon vapors coming from the tank. The flame flashed back into the tank. An internal deflagration blew the vessel head into multiple fragments.

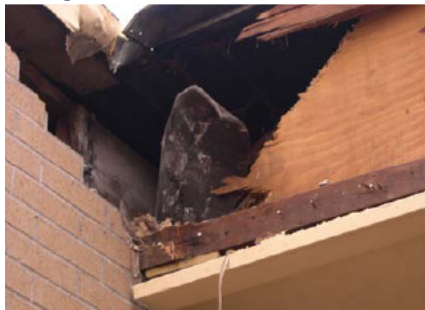
20-lb tank fragment embedded in a wall 300 feet from company property line

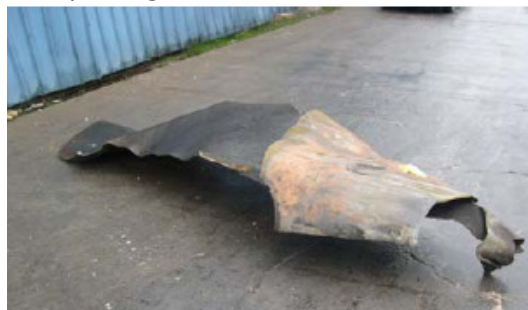
750-lb tank fragment landed near employees (both photos from CSB report)

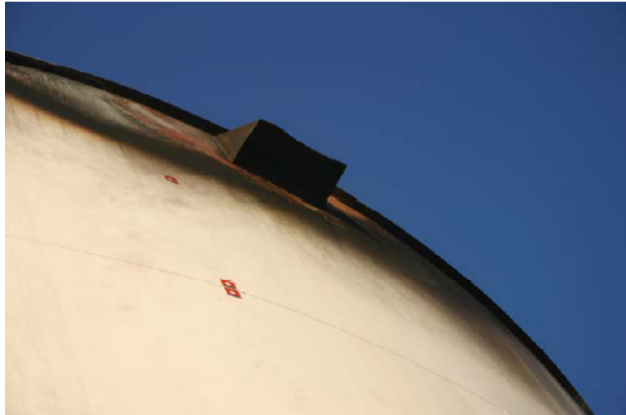
On 12 January 2009, at the Silver Eagle Refinery, Woods Cross, Utah, flammable vapors were released from the tank vent at left while the tank was being filled with light naphtha under atmospheric pressure. The resulting vapor cloud found an ignition source, resulting in an ensuing flash fire 230 feet long. Two refinery operators and two contractors suffered serious burns. The tank contents, which contained an estimated 440,000 gallons of naphtha, did not catch fire.

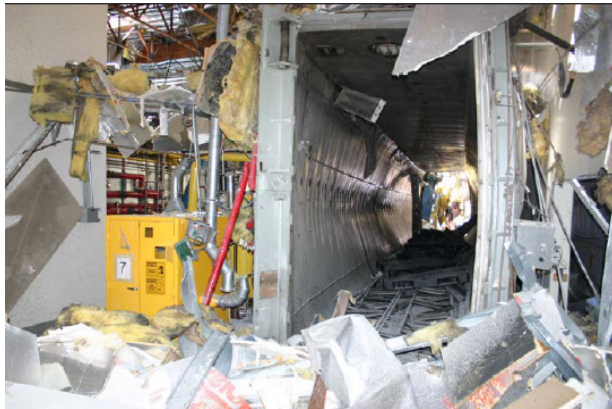
Sterilization chamber, after explosion

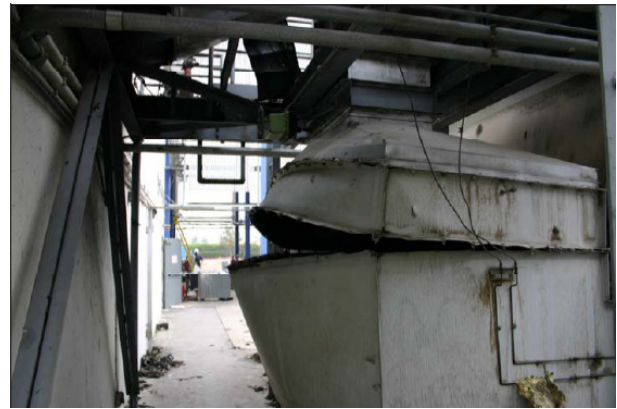
Catalytic oxidizer, after explosion

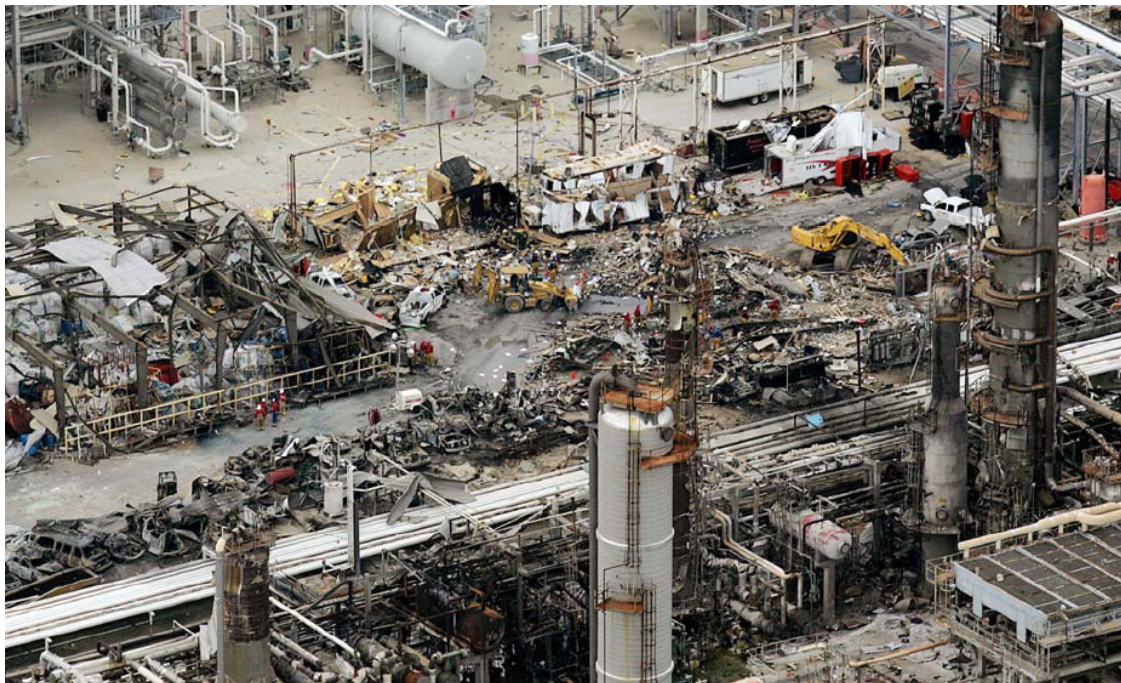
On 23 March 2005, the worst U.S. workplace accident in 16 years occurred at the BP Texas City refinery when flammable vapors from a blow down vent formed a vapor cloud and ignited, apparently from an idling diesel pickup located about 25 feet away. The resulting explosion and fire killed 15 workers and injured 180. The accident occurred during startup of the refinery's octane-boosting isomerization unit (boosts octane content of gasoline), when a distillation tower and attached blowdown drum were overfilled with highly flammable liquid hydrocarbons (the major part of gasoline). Because the blowdown drum was vented to the atmosphere, there was a geyser-like release of flammable liquid and vapor onto the grounds nearby causing a series of explosions and fires that killed 15 workers in and around nearby trailers. Houses were damaged up to ¾ miles away from the site. The blast was felt up to 5 miles away. A shelter-in-place order was issued that required 45,000 people to remain indoors.

After the explosion and fire. From CSB report 2005-04-1-I-TX

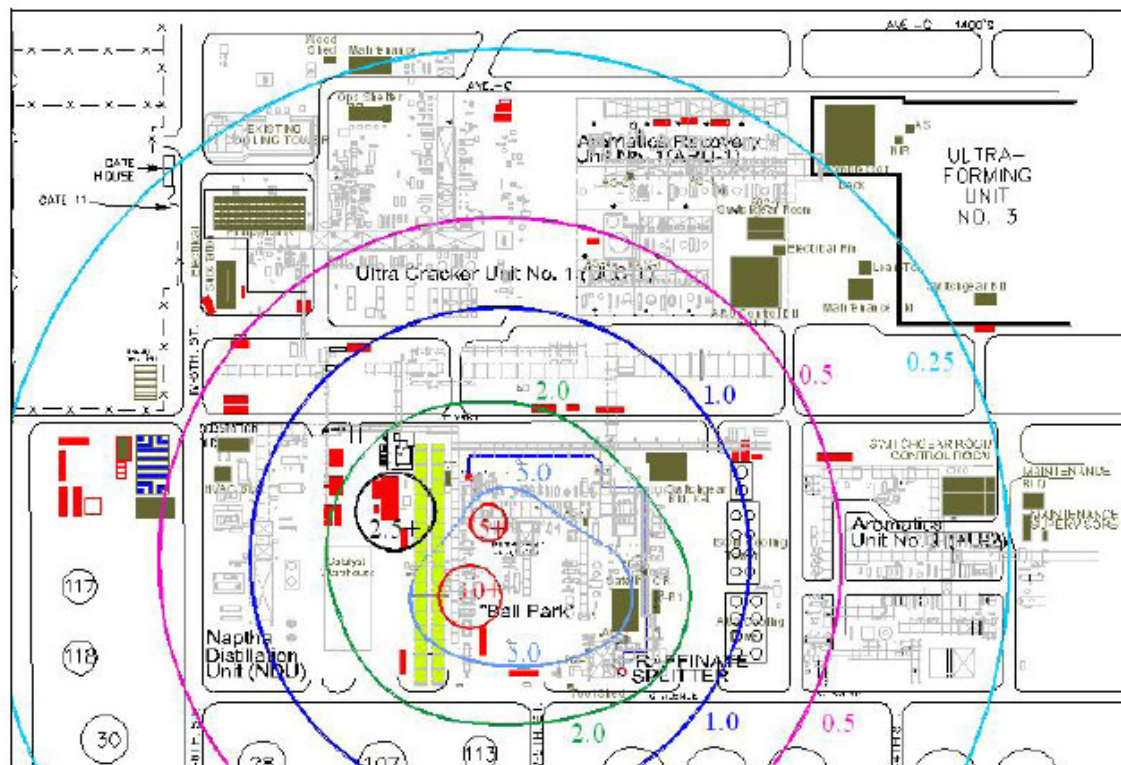
Blast overpressure map, based on site observations, structural analysis, and blast modeling. Over pressure circles at 10+, 5+, and 2.5+ psi; also 2.0, 1.0 (320 feet from center) 0.5 (540 feet), and 0.25 psi (940 feet). The 0.1 psi overpressure line (not shown) occurred at about 2000 ft. from the center, consistent with observations of furthest identifiable glass damage. Unfortunately, the CSB did not provide a scale for the map so these are our estimates based on text statements in the report.

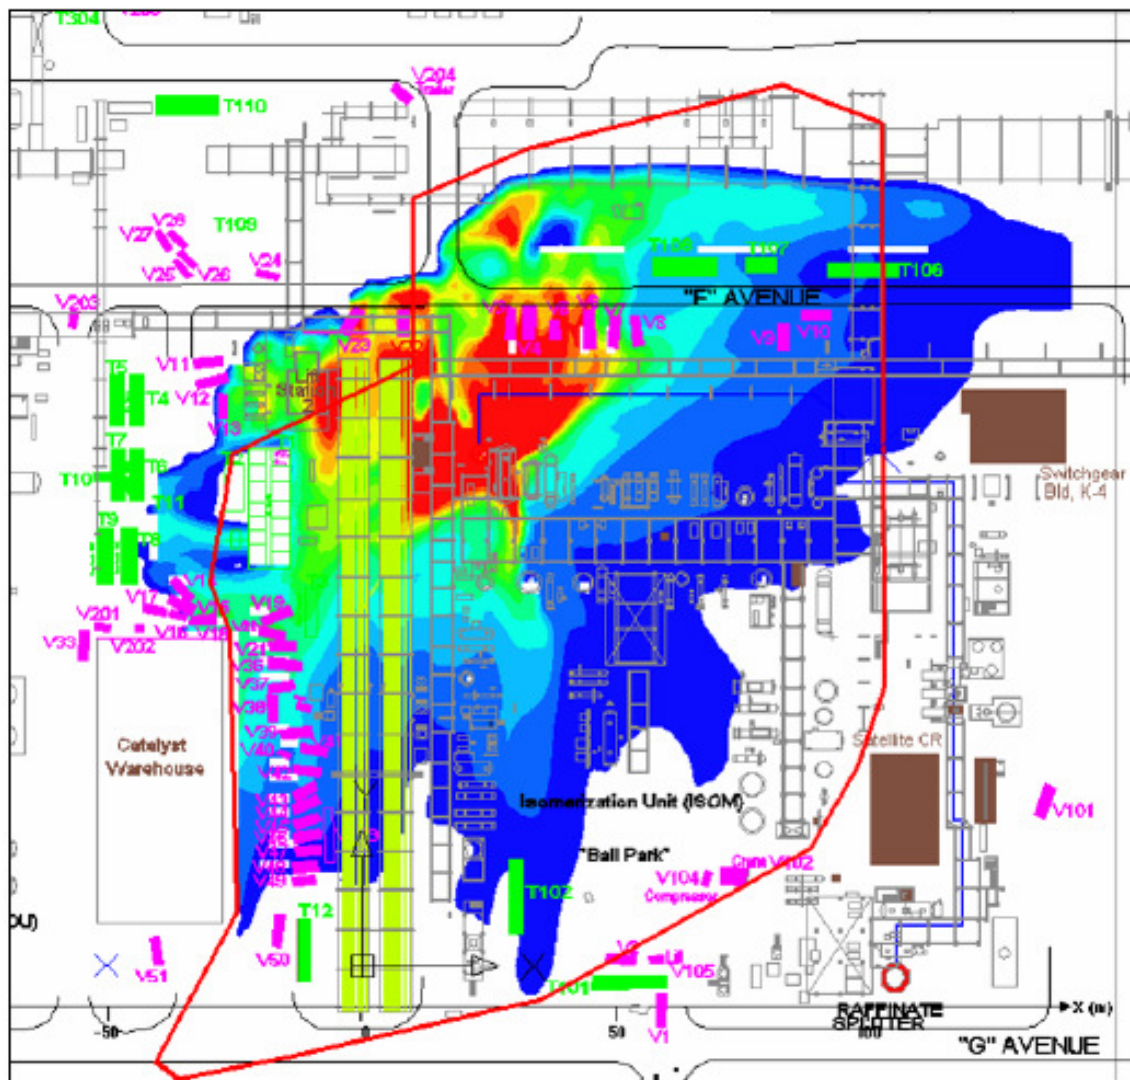
Estimated Vapor Cloud location. Field observations (red line), dispersion modeling (solid colors). From CSB report. Unfortunately, the CSB did not provide a distance scale for the sketch.

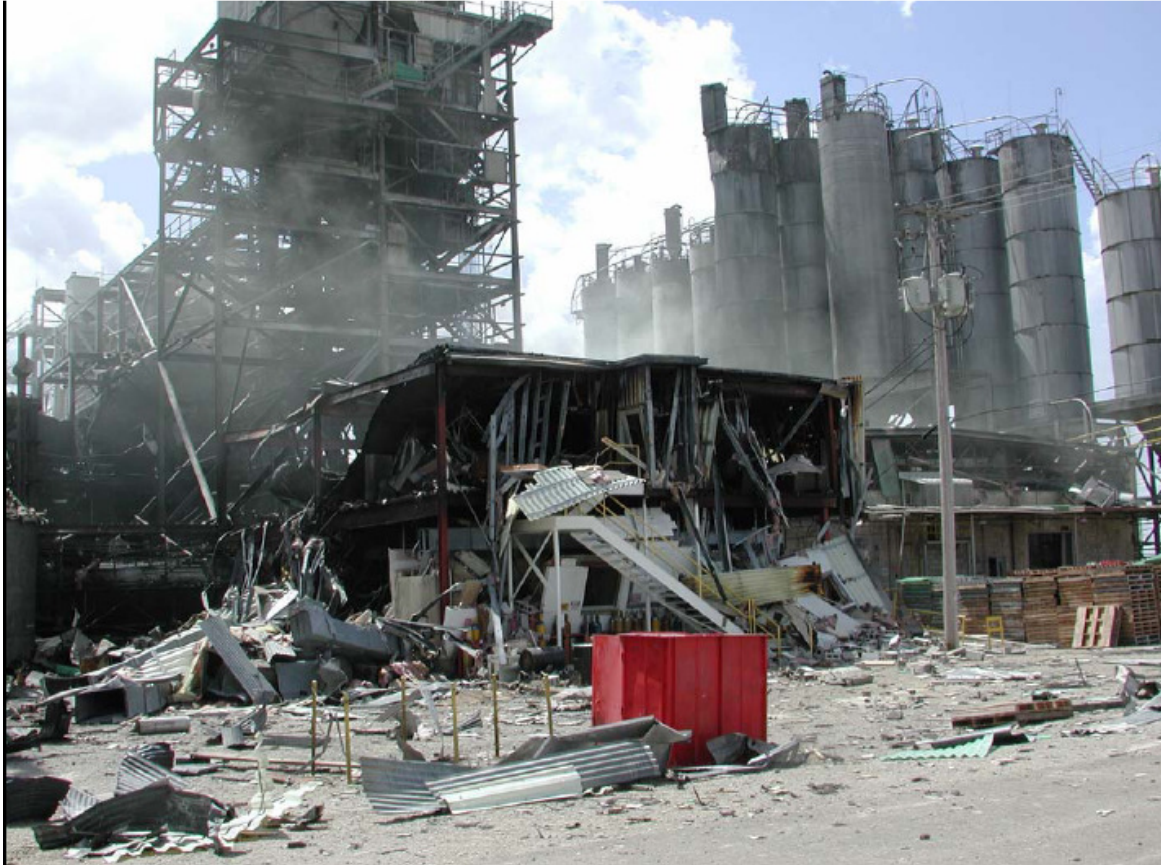
On 23 April 2004, an explosion and fire occurred at a polyvinyl chloride (PCV) manufacturing facility killing five and injuring three employees. The resulting fire spread to PVC resins stored in a nearby warehouse, resulting in smoke drifting over the nearby community of Illiopolis, Illinois. The community within one mile of the site evacuated for two days. The facility was shut down and not rebuilt.

Vinyl chloride monomer is used in the manufacture of PCV. The chemical has a boiling point of 7°F (-14°C), a lower explosive limit of 3.6%, toxic (OSHA 8-hr permissible exposure limit of 1 ppm, and a potential occupational carcinogen. The CSB report determined that the explosion occurred when an operator drained a full and pressurized PVC reactor. Another operator cleaning a nearby reactor apparently opened the bottom valve of an operating releasing approximately 15000 lbs vinyl chloride monomer, PVC, and other ingredients. The two operators and the shift supervisor attempted to manage the release and did not evacuate and subsequently died when the released vinyl chloride contacted an ignition source. Two other workers were also killed, including one who died in the hospital two weeks later.

The root cause was confusion on the part of an operator or operators as to which valve to open, and that the interlock protection for the bottom valve had been bypassed. The company had an emergency transfer procedure to transfer reactor contents to another reactor in case of excessive pressure buildup in a reactor which required them to open the bottom valves and transfer valves to connect the reactor

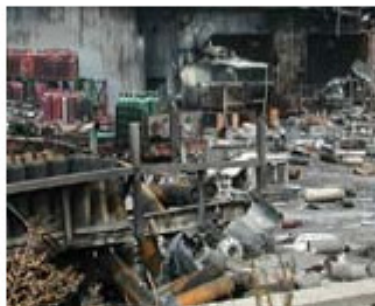
At left is the facility after fire engulfed thousands of cylinders of propylene, propane, acetylene, and other flammable gases. During the fire, exploding gas cylinders or cylinder parts were launched into the community.

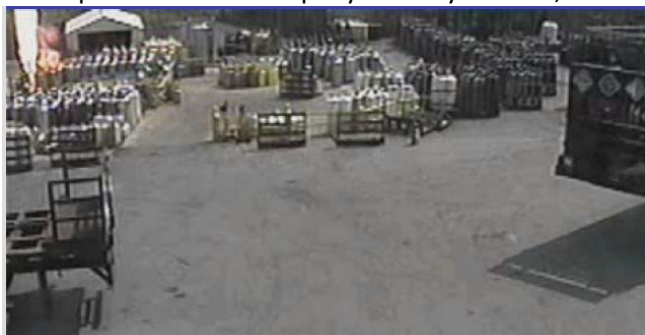
Security camera view, One cylinder catches fire (upper left), 3:20 PM, the start of the incident.

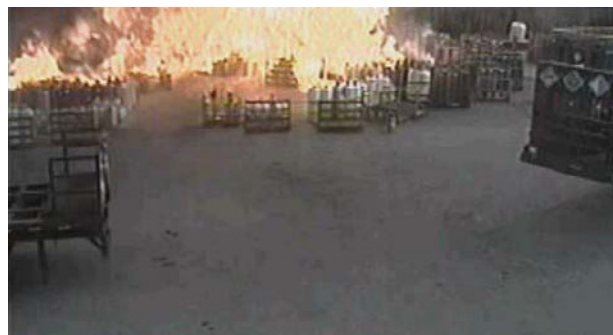
Security camera, fire spreads after three minutes; cylinders are starting rocket at two minutes

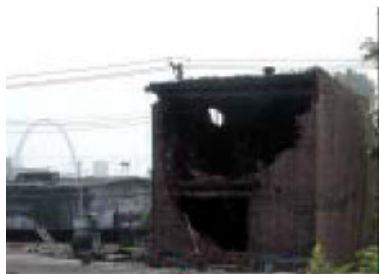
Burned out vacant commercial building, 300 feet away, from rocketing burning fragments

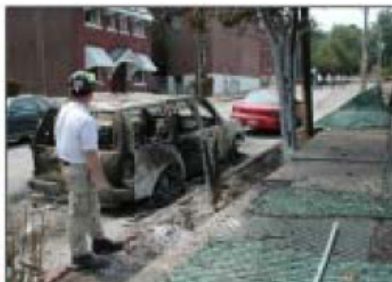
Burned out car, 200 feet away; several cars catch fire due to burning cylinder fragments

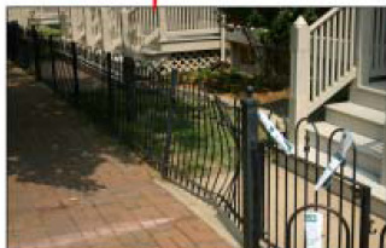
Rocketing gas cylinder glances off car and comes to rest here, 600 feet away

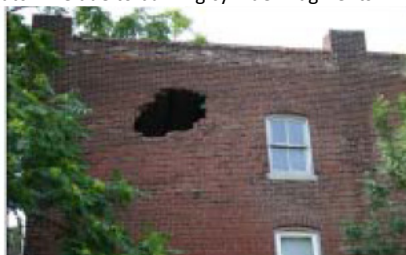
3-foot hole in side of residential building due to rocketing fragment, 530 feet away

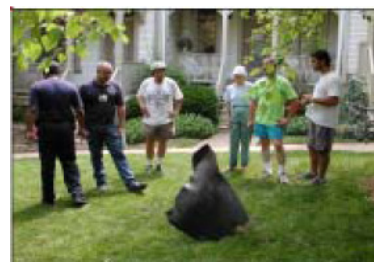
Fragment, 500 feet away
