Runaway Industrial Chemical Reactions

Example Incident: T2 Laboratories, Inc., Jacksonville FL, 19 December 2007

Example Incident: Synthron, LLC, Morganton NC, 31 January 2006

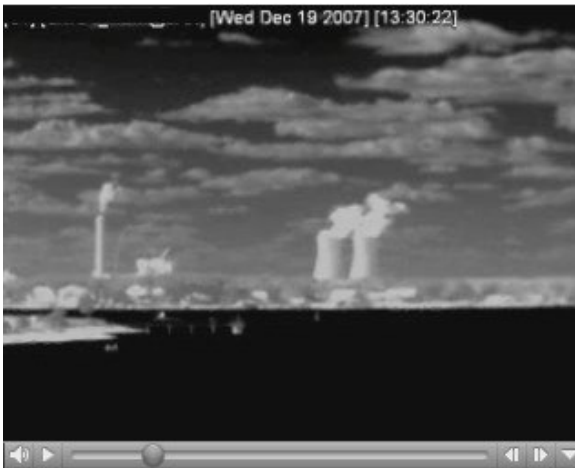
Coast Guard surveillance video watching Jacksonville harbor freezes the time of the blast. Stack at left and two cooling towers at center right are incidental. From CSB website.

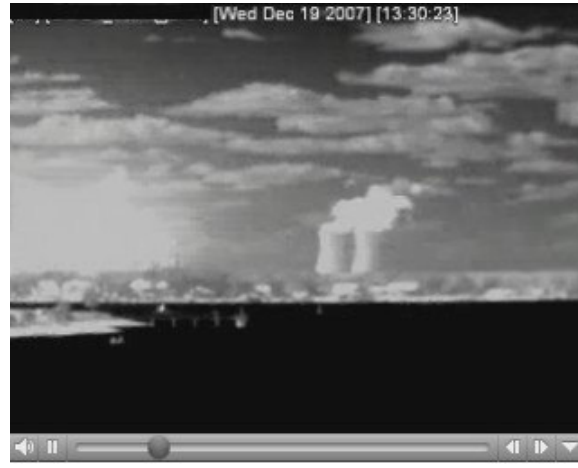
Coast Guard surveillance video watching Jacksonville harbor freezes the moment the blast is first seen from a distance, one second later, at left.

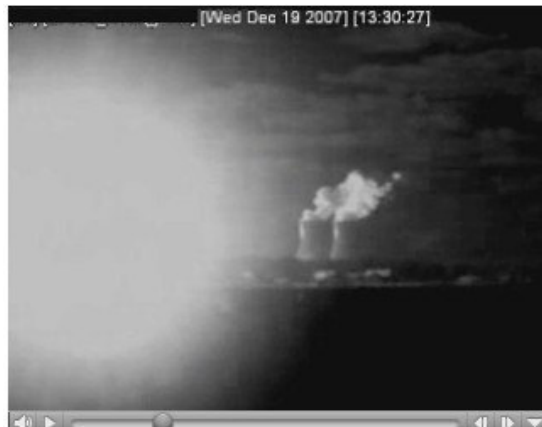
Coast Guard surveillance video captures the scene five seconds later when the explosion is the most brilliant. (a vapor cloud explosion)

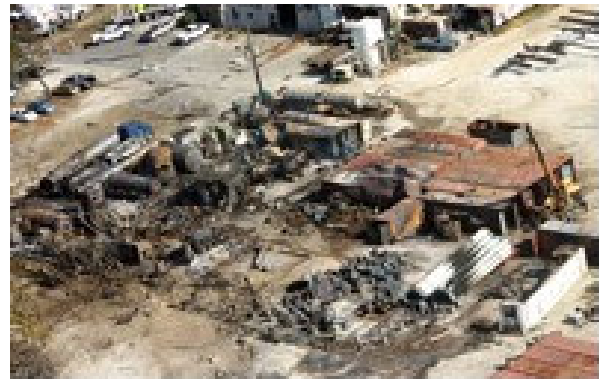
Aerial view of site after blast from CSB bulletin

On 19 December 2007, at about 1:30 PM an explosion occurred at T2 Laboratories in Jacksonville, Florida. The explosion killed four T2 workers and resulted in hospitalizing 14 other people. Injuries requiring medical attention occurred as far away as 750 feet from the site. The blast was felt several miles away. Over 100 firefighters fought the ensuing blaze, which was described as a hellish inferno.

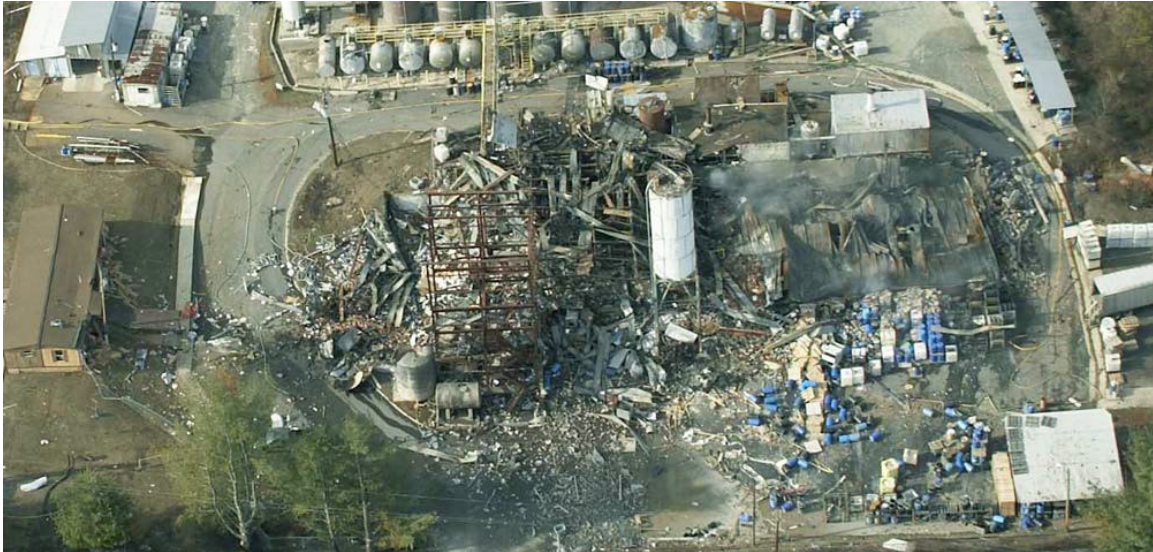
Illustration of Synthron site after the blast from CSB Report 2006-04-1. Morganton Dept. of Public Safety.

The blast damaged buildings nearby. Two church buildings and one house was condemned. Glass was broken up to one-third a mile distant from the site. The Morganton Department of Public Safety responded rapidly calling mutual aid from the county and surrounding municipalities, to assist injured employees and extinguish the resulting fire. Local residents were asked to shelter-in-place for several hours.

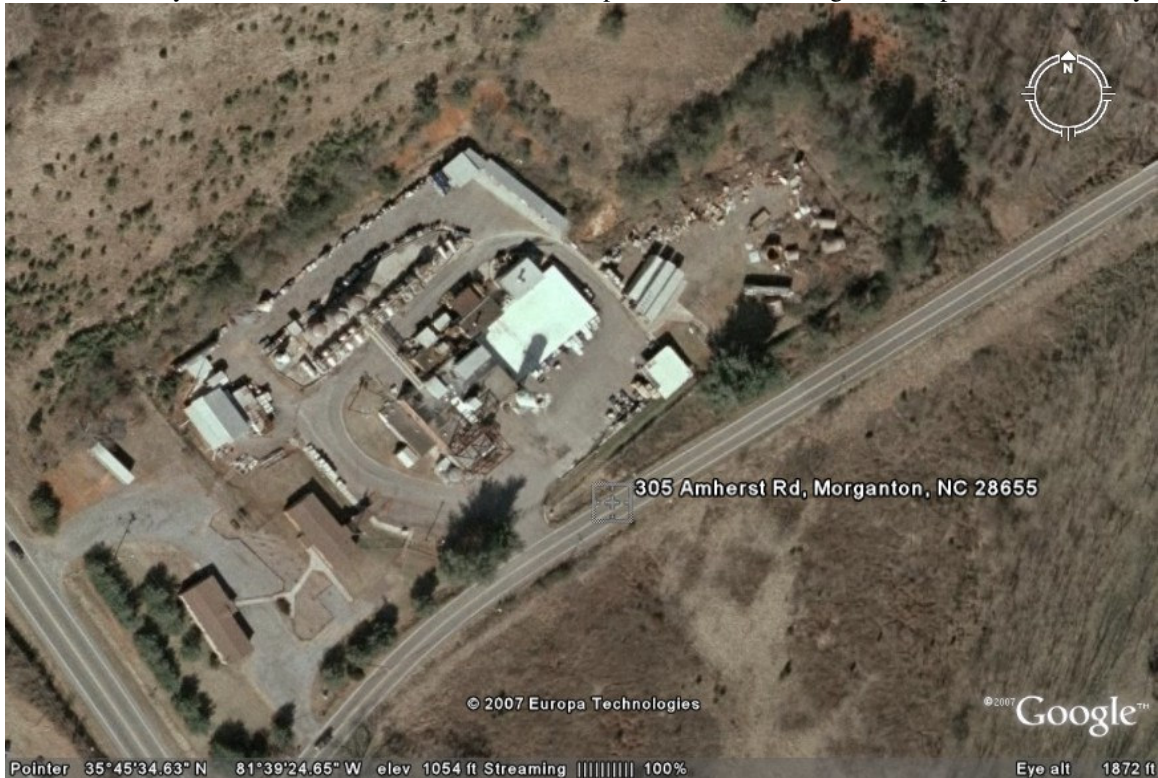
Google Earth image of the Synthron facility before the blast
