AN ANALYSIS OF A VAPOR CLOUD EXPLOSION

November 2006 Explosion at CAI/Arnel in Danvers, Massachusetts

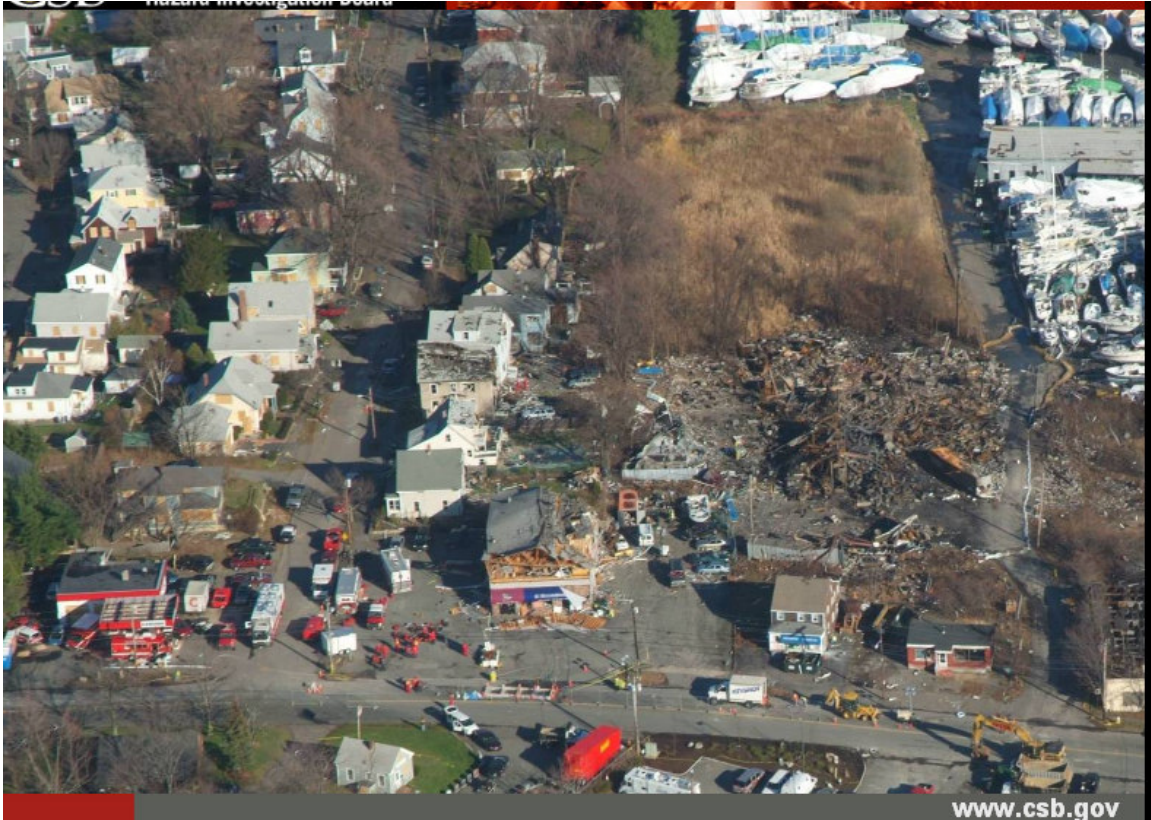
The blast site, obliterated facility at right; note proximity of houses.

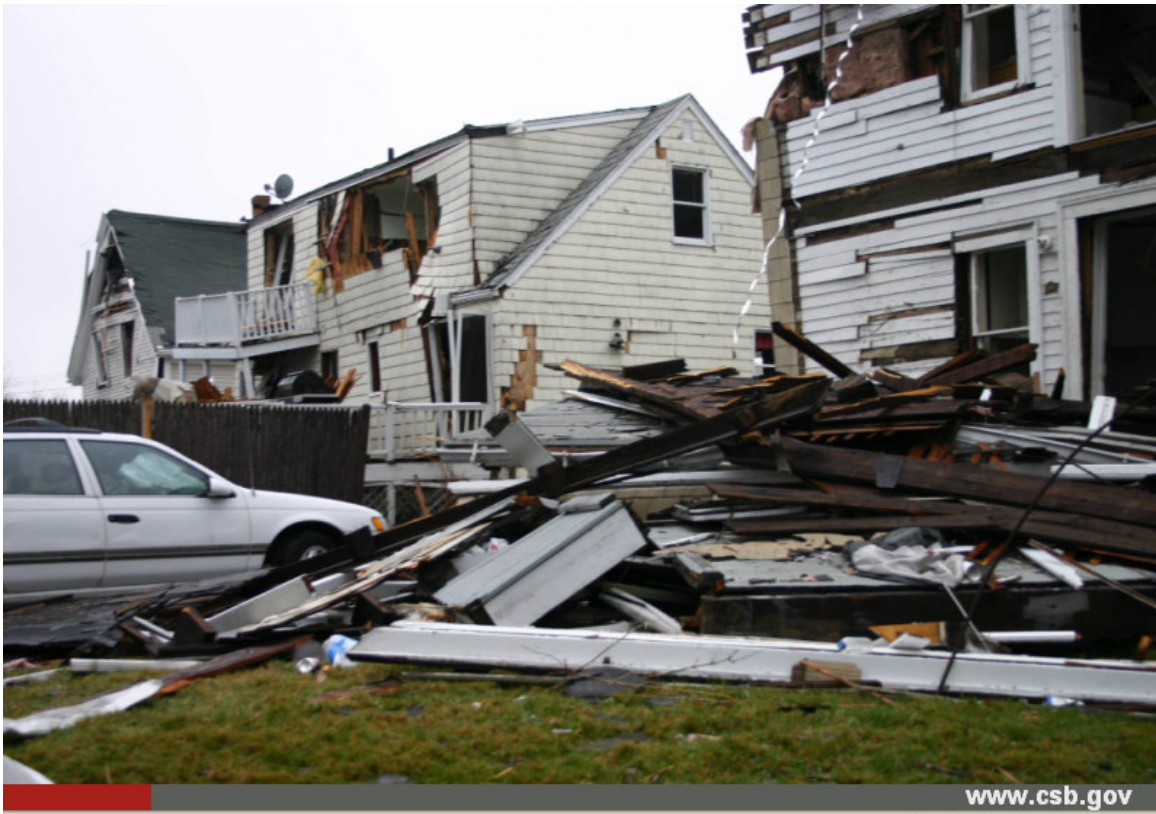
Severe structural damage to nearby houses occurred because of the blast

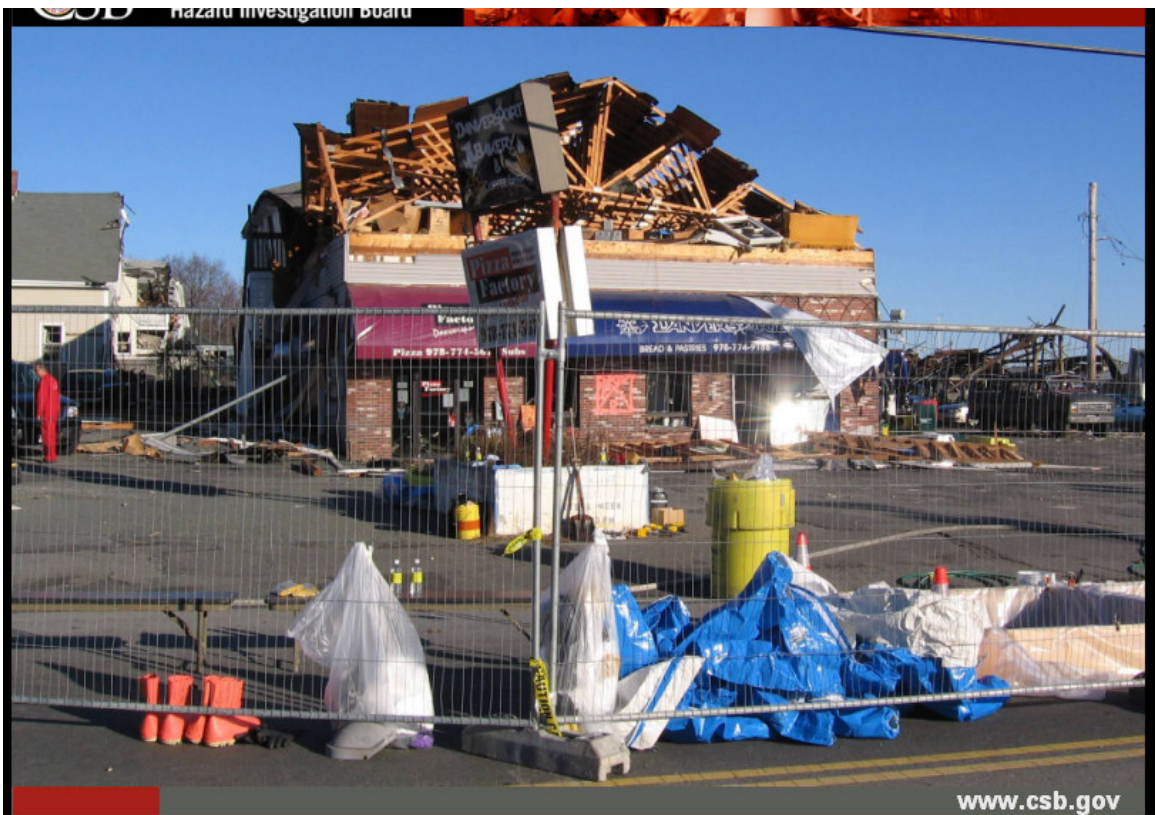
Businesses were damaged because of the blast

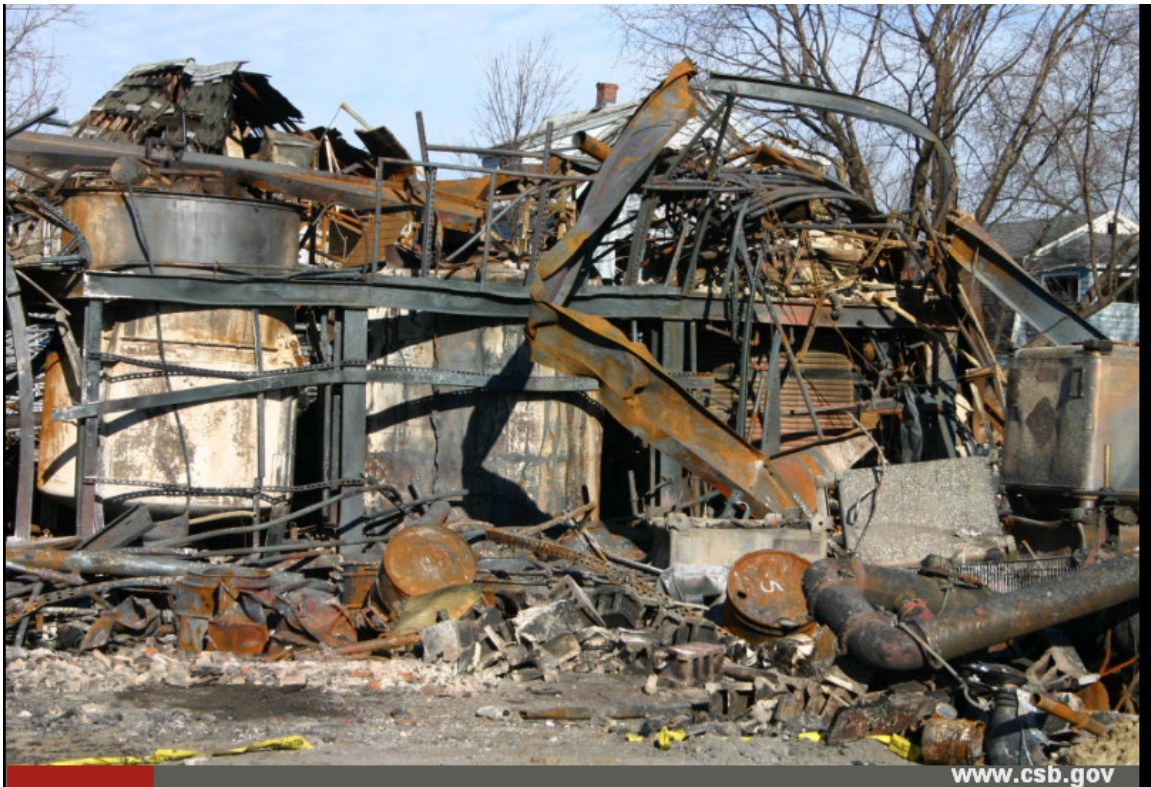
The CSB examined what was left of equipment at the facility. Note proximity of nearby house at right.

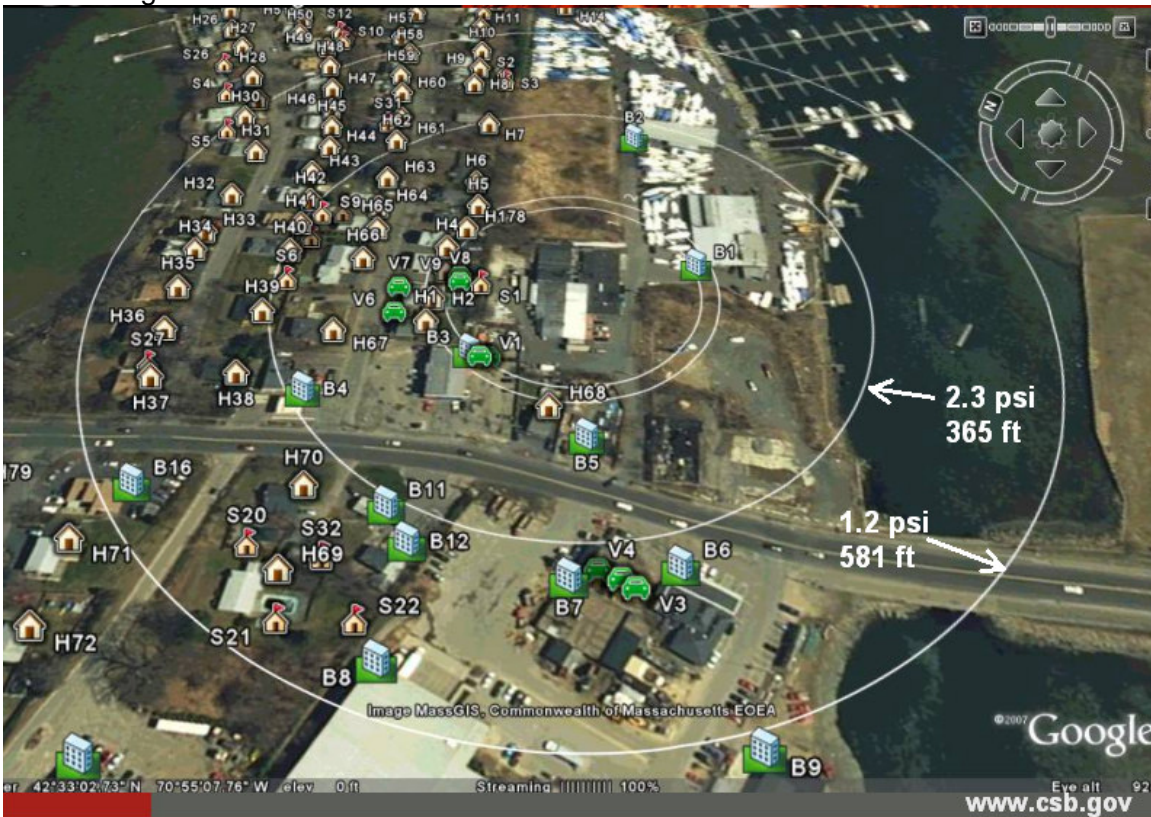
A key part of the CSB investigation was to map damage assessment as a function of distance from “ground zero” and relate to peak blast overpressure. The above image is

a projection of the findings on an aerial photo supplied by Google taken before the accident.

Perhaps the best way of estimating the amount of chemical is to back calculate from the map CSB used for overpressure damage estimates. Using the PEAC tool, we calculate a minimum of 1630 lbs of n-heptane (or 2400 lbs of n-propanol) for the blast pressures. More likely, there would be some mix of the two chemicals, and the amount could be as close to 5000 lbs of n-heptane (or a mix the two chemicals). Both numbers are within range of the amount of chemicals charged in the mix tank and would produce vapor concentrations between the upper and lower explosive limits within the building.

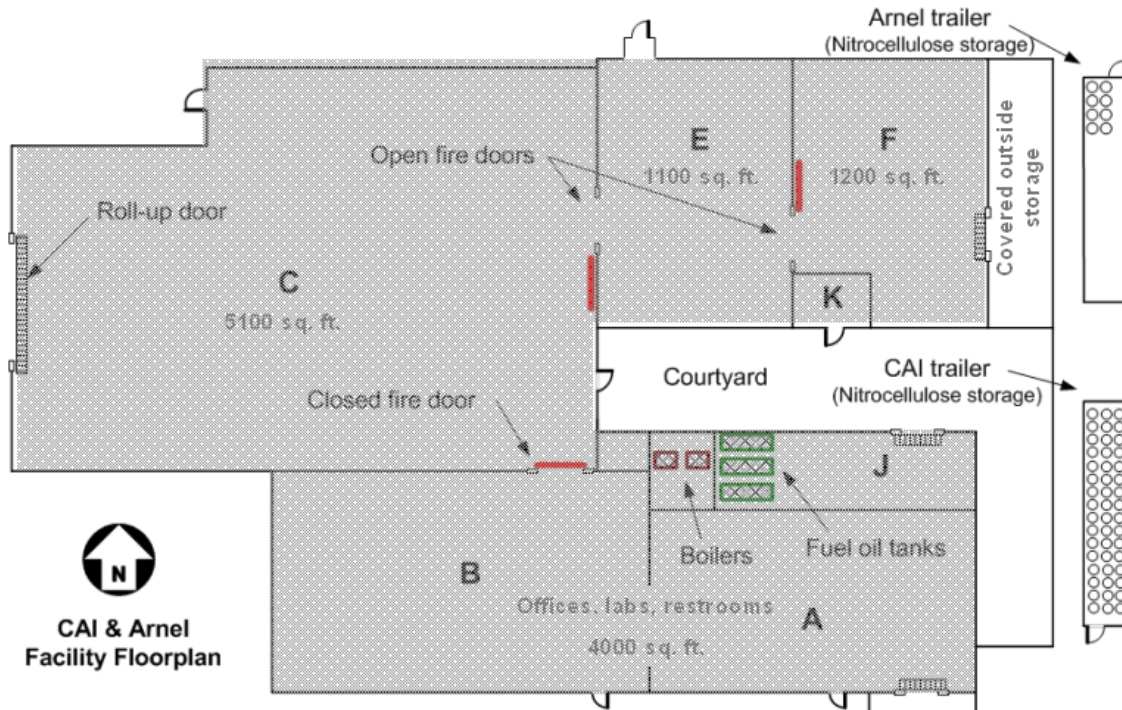
The Facility floor plan was examined. Attention was focused on room “C”. Rooms E and F are also used in production, but on the night of November 21-22, there was no overnight solvent processing and the rooms were empty of chemicals except for small batch quantities

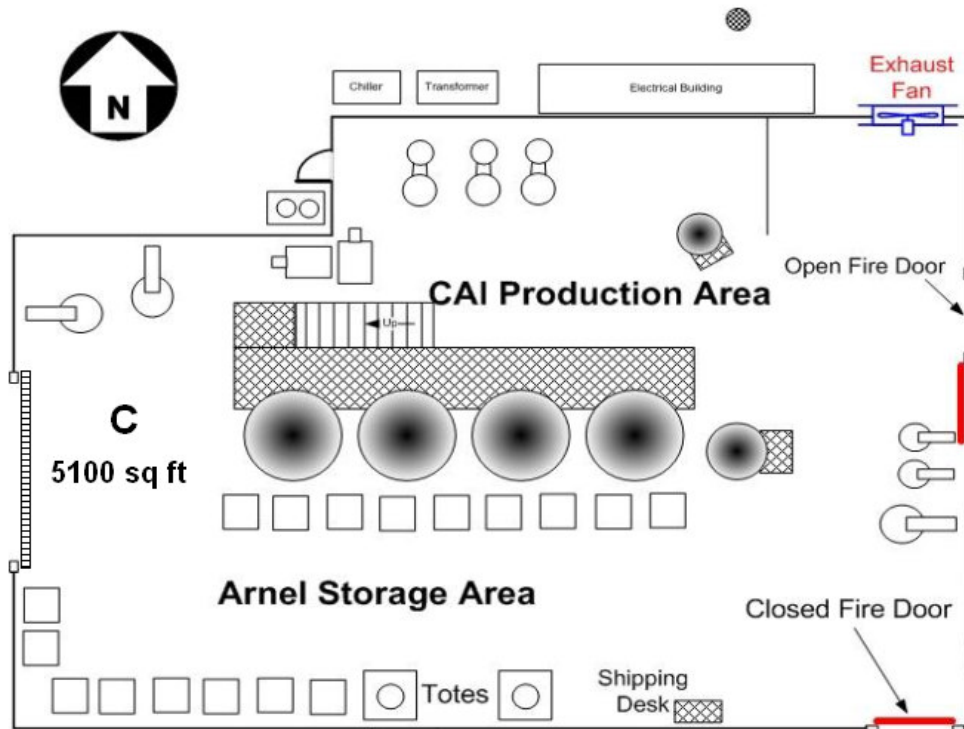
Overnight (unattended) solvent processing occurred in room C during the night of November 21-22. Workers reported that it was customary to turn off the exhaust fan during unattended overnight processing to save building heat. The CSB investigation eliminated (1) natural gas, (2) fuel oil, and/or (3) nitrocellulose as the possible source of the explosion. None of these sources were capable of producing the blast damage seen. The nitrocellulose at the facility did not explode but burned rapidly inside the storage trailers. The CAI/Arnel facility did not have natural gas service. The closest natural gas pipeline to the CAI/Arnel building was 215 feet south, and there was no post-explosion natural gas fire or leak. The fuel oil tanks were intact after the explosion.
