More on Vapor Cloud Explosions and Fires

Kleen Energy Natural Gas Explosion, Middletown CT, Six Workers Killed.

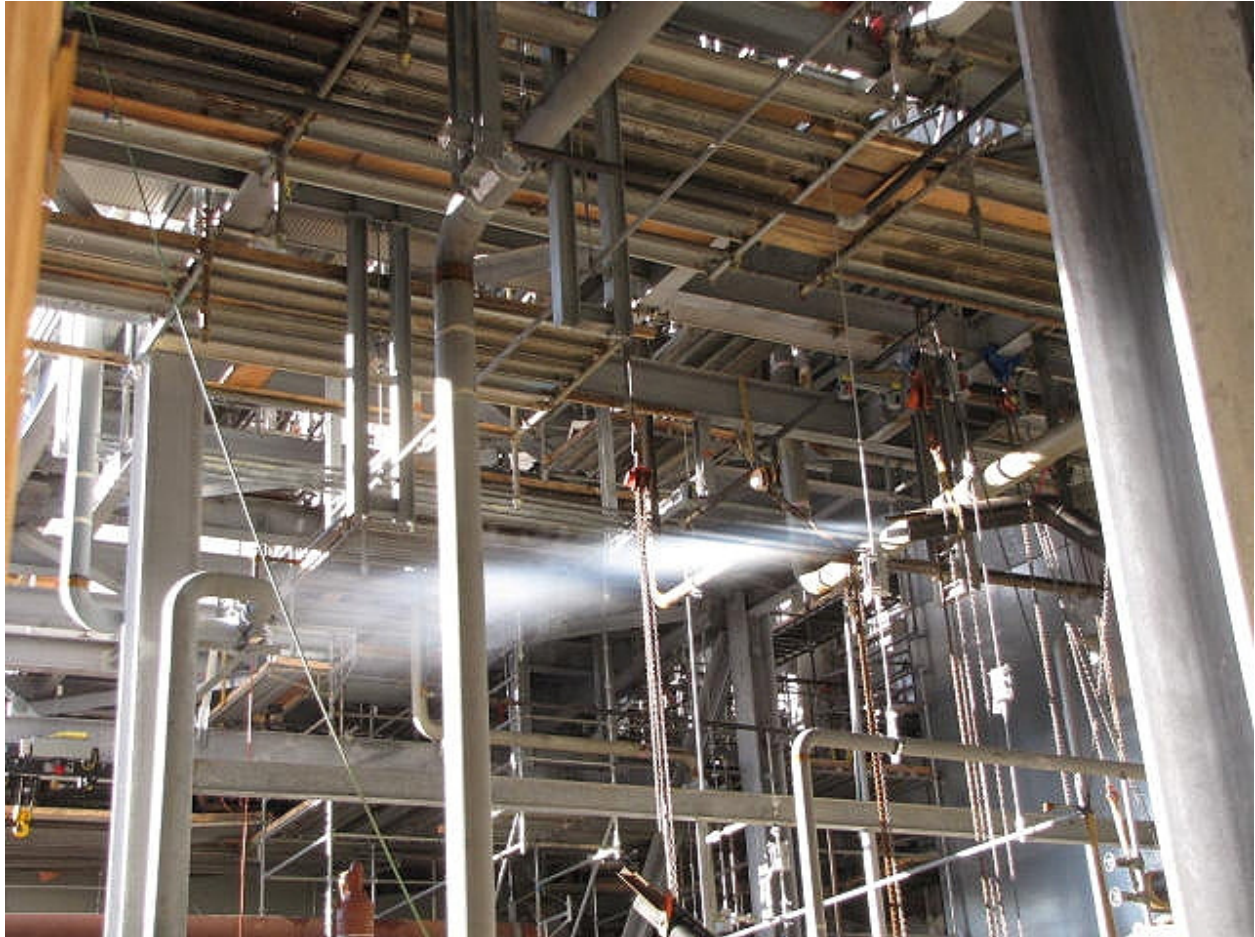
The Chemical Safety Board (CSB) investigation (<http://www.csb.gov/investigations/detail.aspx?SID=91&Type=2&pg=1&>) noted that while Kleen Energy followed written procedures for venting and also took care to remove outdoor ignition sources, work continued inside the main power generation building including welders actively working. The building electric power was on, and diesel-fueled heaters were running. OSHA investigation also noted that several of the 150 workers on site on the day of the explosion had worked in excess of 90 hours during the previous week. Some workers inside the building made a personal decision to exit the building prior to the explosion because they were alarmed by the smell of the natural gas odorant. All six fatalities and 50+ injuries were within the building. As seen by Figure 1, the

natural gas venting may occur in somewhat confined spaces near building structures. The vents were adjacent to the south wall of the building.

Figure 1: Natural gas venting during purging of lines, photo taken on Feb. 7 before explosion (used in CSB report)

The explosion occurred at Kleen Energy’s combined-cycle natural gas fueled power plant which was finishing the final stages of construction and beginning startup. By “combined cycle” is meant that natural gas is combusted to drive massive turbines with the residual heat from combustion used to generate steam, which in turn is used to drive more turbines as in a conventional power plant. It is essential that the flue gas (from combustion of natural gas) used to drive the turbines be clean, that is, free of anything that might deposit on the turbine blades. This means that the lines used to convey the natural gas and flue gas must be absolutely free of any debris resulting from construction. There must be pipe cleaning before startup. Kleen Energy used the natural gas available at the site at 650 pounds per square inch pressure to purge their lines venting the gas to the outside air. A total of 15 natural gas blows were completed intermittently over a four-hour period on February 7 prior to the explosion which occurred at approximately 10:15 AM. According to Chemical Safety Board calculations, a little over 2 million standard cubic feet of natural gas were used for purging in the morning with about 400,000 standard cubic feet released 10 minutes prior to the incident. Venting occurred at several outdoor open pipe locations located less than 20 feet off the ground including one as such as shown in figure 1.

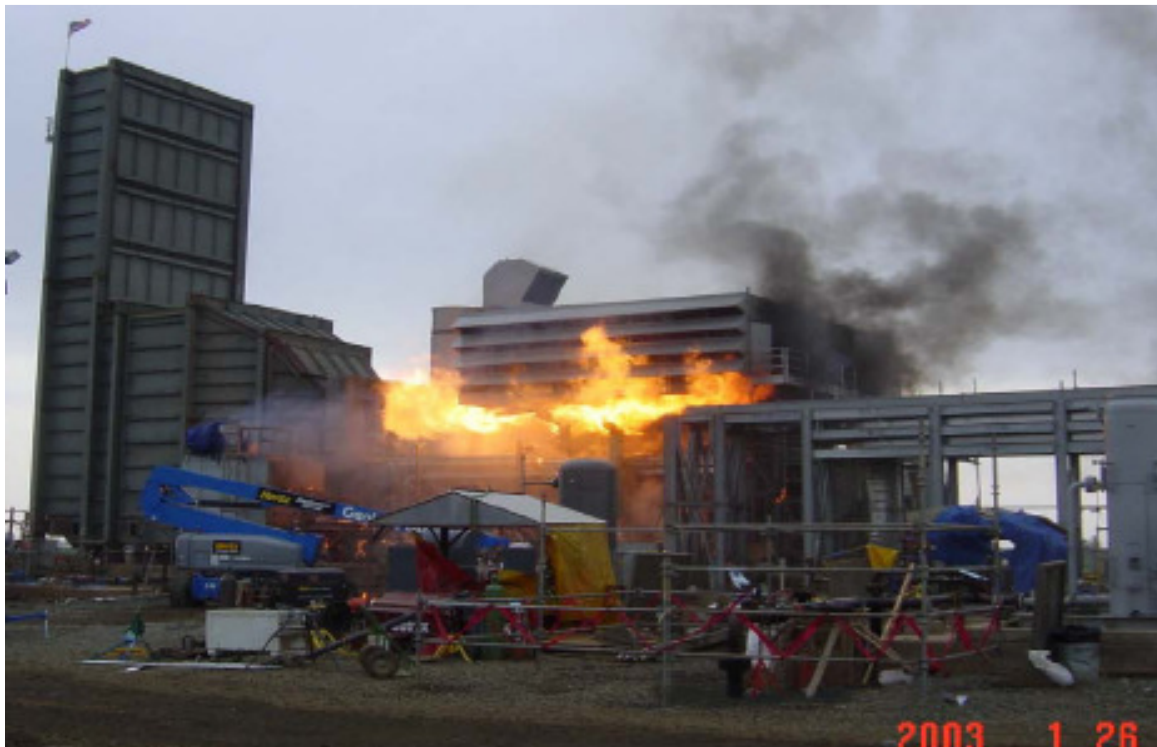
Figure 3. Calpine Wolfskill Power Plant, 26 January 2003. Photo from CSB report at <http://76.227.217.14/UserFiles/file/FINAL%20Urgent%20Recommendation.pdf>.

This incident occurred on 26 January 2003 during pre-commissioning of the Wolfskill Energy Center natural gas power plant in Fairfield, California. High-pressure natural gas at approximately 630 psig was used to flush out the gas lines of debris and vented through four-inch open-ended pipe directly to the atmosphere. Seven people were at the site, either directing the operations or observing as in the case of the local fire department. Non-essential personnel were cleared from the area. Fortunately no one was injured when the explosion occurred, which shattered windows a quarter of a mile away and was heard up to ten miles from the site. The debris was projected over the heads of the people at the site and did not hit anyone. The ignition source was not determined, but Calpine's investigation concluded that the explosion was most likely ignited by static electricity. Calpine concluded that the use of natural gas to purge piping while convenient has risks. Calpine facilities now do not allow the use of natural gas to clean piping and instead use compressed air.

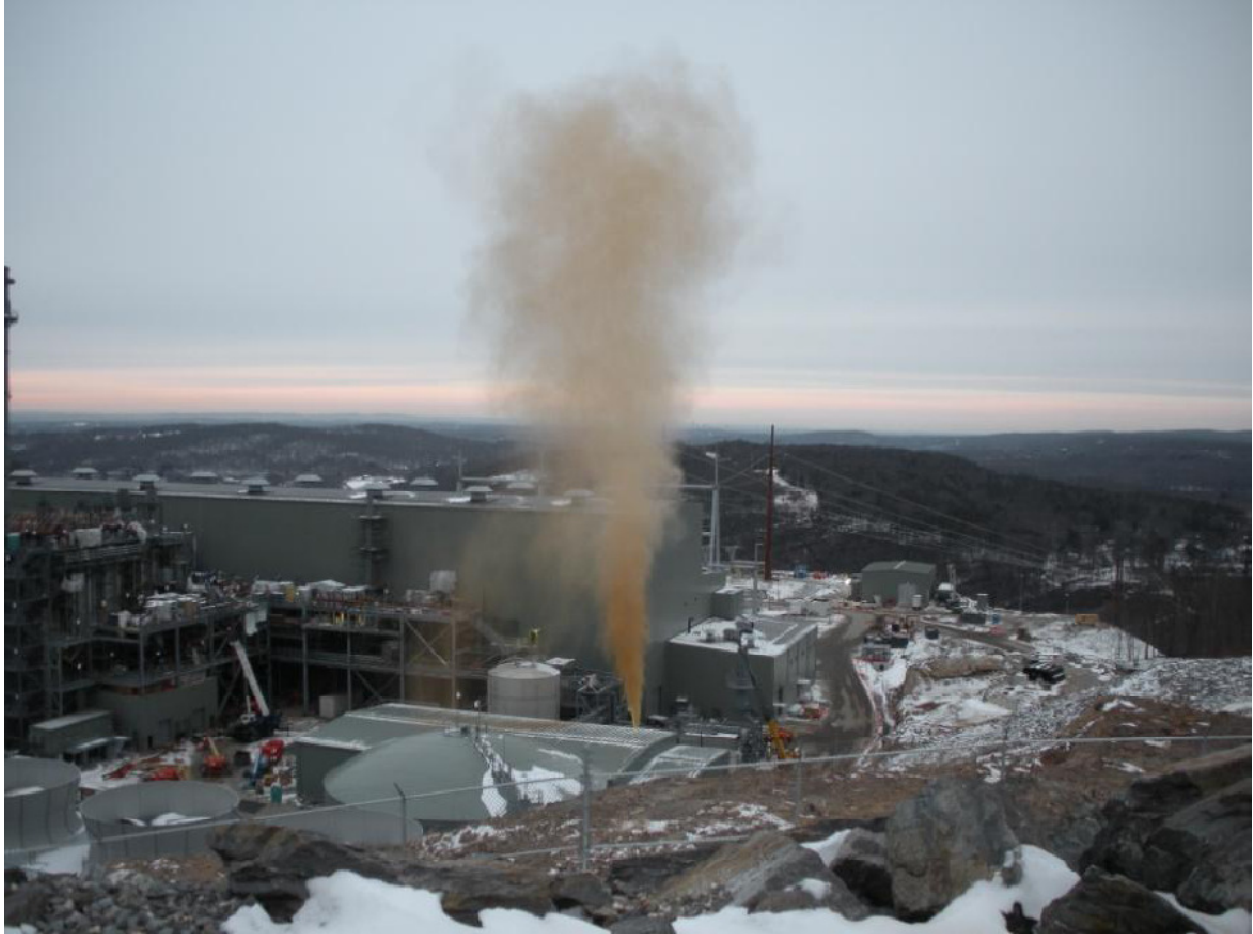
Figure 4. A gas blow from an electric power plant used to remove debris from piping. The brown cloud represents debris in the lines. Photo, Kleen Energy, 30 January 2010, as used in a CSB report urging changes in regulations and standards, <http://76.227.217.14/UserFiles/file/FINAL%20Urgent%20Recommendation.pdf>.

The Chemical Safety Board conducted a survey of combined cycle natural gas fueled power plants. Of the 62 responses received, 63% indicated use of “natural gas blows” to clean piping. One response indicated use of flare to destroy flammables vented during natural gas blows. Other facilities used pigging and air flow, air blow, nitrogen blow, chemical and water cleaning, or steam blow or a combination thereof. The organization also concluded that in the case of Kleen Energy significantly more gas was released than was actually needed to clean the piping. They also recommended revising the National Fire Protection Codes 54, 37, and 850, the ASME B31.1 standard, and FM Global’s “Natural Gas and Gas Piping” standard to incorporate safer practices. OSHA regulations contain many gaps in release of flammable gas in the vicinity of workers. There are no standards specific to the power industry that address the cleaning of power plant fuel lines. There are safer methods of cleaning fuel lines. Details are at http://www.csb.gov/assets/document/Kleen%20Energy%20Public%20Meeting%20Presentation_6%2028%202010.pdf.

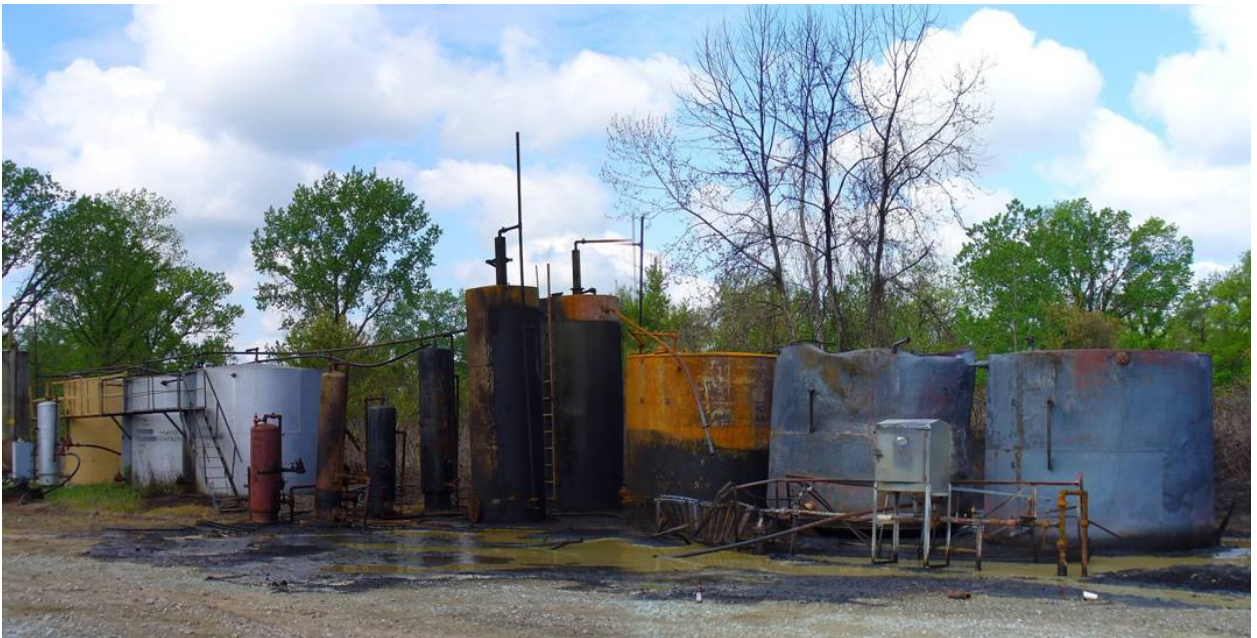
- 14 April 2010, 9 PM, near Weeletka, Oklahoma. Six young adults driving on a public road noticed an open gate and entered an unmanned oil production site containing four petroleum storage tanks and two brine tanks. The explosion occurred about 10 minutes after the young adults arrived at a site, when a 21-year-old male climbed up the catwalk leading to the top of one of the tanks and opened a hatch and peered inside. The resulting explosion, apparently caused by a lit cigarette or lighter, killed the man. A second explosion occurred in an interconnected tank. Another youth suffered second degree burns. The resulting fire burned for more than three hours before it was extinguished by several responding fire departments using foam. Figure 5, below, shows the tanks after fire departments extinguished the fire.

Figure 5. Oil production site, after fire, from <http://www.csb.gov/newsroom/detail.aspx?nid=315>.

CSB investigators spent 4 days at the site interviewing witnesses and determining what happened. The victim who was killed lived for a few hours after being engulfed in flames, and was able to describe the accident to emergency response personnel. The site entrance was protected only by an unmarked gate which was described as being wide open on the night of April 14, and generally open and unlocked at other times, and there was no protective fencing. The tank hatches had no mechanism to allow securement, and the catwalk leading to the tank

top was readily accessible. The CSB investigators also observed other oil and gas production sites in the area and found most of them were unsecured and had no warning signs. Oklahoma has approximately 257,000 active and unplugged oil and gas production sites, and requires fencing and warning signs only at sites that have hydrogen sulfide hazards.
