## Real-World Explosions and Fire Examples by Dr. John Nordin

We will take a snapshot look at example explosions and fires involving chemicals including fuels. Many of the examples chosen occurred at U.S. industrial facilities. Major accidents at these locations are investigated by governmental agencies such as the Chemical Safety Board, the Department of Transportation, Occupational Safety and Health Administration, and the Environmental Protection Agency, and their reports are published and available in the public domain. Other investigations are done by insurance companies. Similar investigations are done by appropriate governmental agencies in several other countries, and the reports are sometimes available. Several of these events are vapor cloud explosions. Some involve tank or vessel explosions and some examples are cascading chain-event accidents. Both catastrophic and smaller scale examples are illustrated.

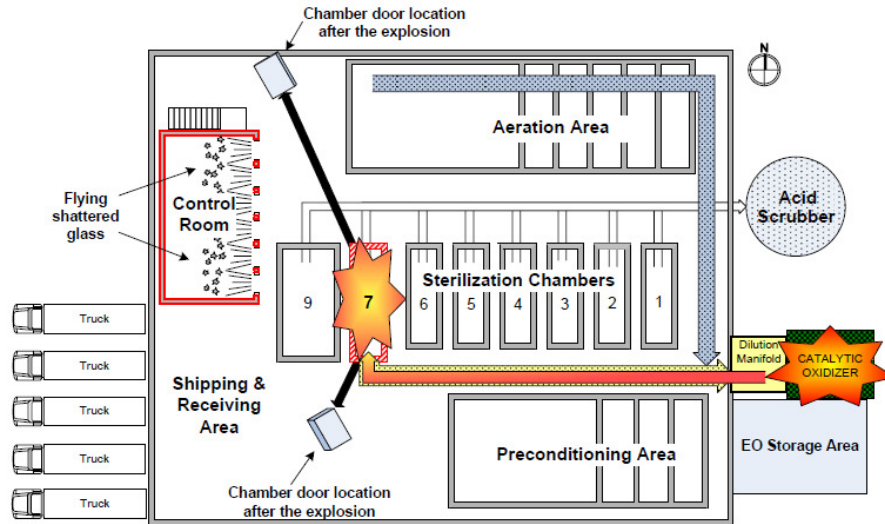
On 19 August 2004, an explosion took place inside an air pollution control device and medical products sterilization chamber at a company in Ontario, California, injuring 4 workers and severely damaging the facility. Ethylene oxide is used as the sterilization chemical for the medical products; the chemical is both highly flammable and toxic (boiling point 51°F, Lower Explosive Limit 2.6%, Upper Explosive Limit 100%, Flash point -20°C, OSHA 8-hour permissible exposure limit 1 ppm). The Chemical Safety and Hazard Board (CSB) Report is available at [http://www.csb.gov/completed\\_investigations/docs/CSBSterigenicsFinalReport.pdf](http://www.csb.gov/completed_investigations/docs/CSBSterigenicsFinalReport.pdf). Normal sterilization procedure is to first subject the medical products contained in their normal packaging to high humidity and warm (80° to 120°F) temperatures for 6 to 24 hours (depending upon the product), followed by injecting gaseous ethylene oxide into specially-designed chambers containing the products. Under these conditions, the ethylene oxide penetrates the packaging to sterilize the medical products. When the sterilization is complete, the chamber is evacuated followed by a series of nitrogen and/or nitrogen-air flushes to reduce the concentration of ethylene oxide to well below the lower explosive limit; the exhaust gas containing ethylene oxide is routed to a scrubber. Additional air flushes are done to decrease the ethylene oxide concentration in the chamber to below toxic levels before workers can enter the chamber to remove the sterilized medical products. The final air venting (containing small amounts of residual ethylene oxide) passes through a catalytic oxidizer before exhausting to the outside.

However, on the day of the explosion, during a system troubleshooting checkout with no medical products in the chamber, operators bypassed some of the flushing steps to save time (a bad decision). Furthermore, chamber had no monitoring or detection equipment to warn operators that an explosive mixture of ethylene oxide remained in the chamber when the chamber door was opened. This caused an estimated 50 lbs of ethylene oxide to vent to the catalytic oxidizer and also into the building setting off nearby LEL alarms. The ethylene oxide ignited in the catalytic oxidizer causing the flame to flash back to the chamber resulting in a powerful explosion. Fortunately, there were no employees in the chamber area at the time of the explosion.

Sterilization chamber, after explosion
