## Using the PEAC tool for Industrial Vapor Cloud Explosion and Fire Accidents

### BP Texas City Refinery Accident

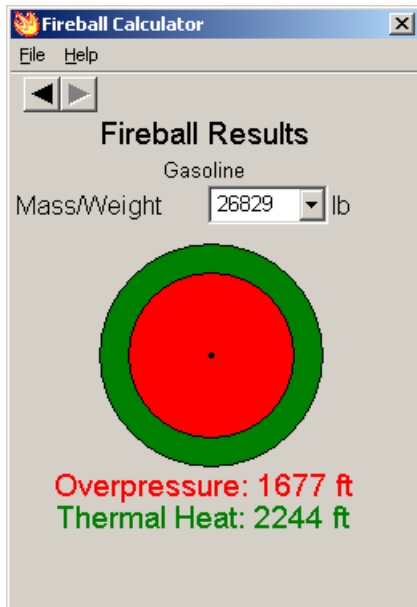
**Calculated standoff distances**

The PEAC tool estimates the mass inside the container (ignoring end curvature) and the blast distance corresponding to a 1 psi overpressure. Assuming that a fireball immediately follows, the PEAC tool also calculates the distance to threshold of second degree burns for exposed flesh (ignoring any secondary fires or explosions). Because of uncertainties of the vapor cloud shape a safety factor of two is applied to all distances from ground zero. At 1 psi overpressure, windows break, and there is structural damage to trailers. The overpressure distance calculated is greater than experienced in the BP accident probably because less hydrocarbon (gasoline) was involved in the BP explosion, and the PEAC tool has a safety factor of 2 on distance. The PEAC tool is not limited to distance calculations linked to 1 psi overpressure or to the threshold for second degree burns. Other overpressures and damage estimates can be entered. The PEAC calculator can generate a list of damage estimates as a function of distance from ground zero, store

the information, and print it later. A safety inspector can generate his lists as he/she walks through the facility, and use this information for developing exclusion zones for trailers and for possible ignition sources such as vehicles. The PEAC tool also automatically will display the standoff distances on a street map.

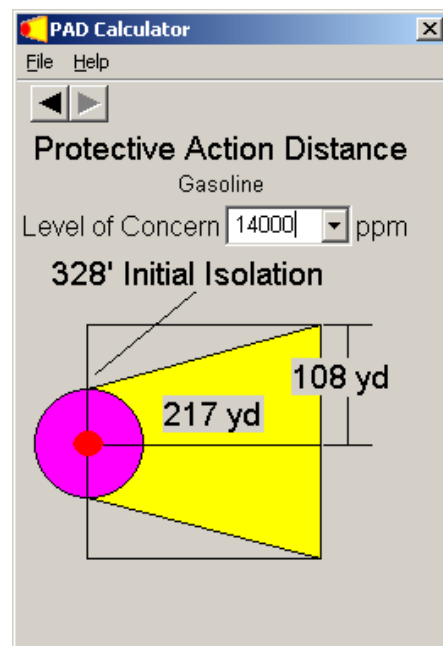
The Lower Explosive Limit for gasoline is 1.4%. This is equivalent to 14,000 parts per million by volume in air. By clicking on the PAD icon on the first screen, the user can estimate a distance downwind corresponding to 14000 parts per million. The worst-case scenario is for all of the gasoline to be released at once, and a clear nighttime sky at under a low wind condition. We will set the PEAC internal clock to a nighttime, specify clear skies, urban condition, a wind speed of 2 miles per hour, and a sudden mass release of 26829 lbs as calculated previously. The PEAC tool calculates that the concentration < 14000 ppm for vapor cloud explosion extends out to 217 yards (651 feet). Under daytime conditions or windy conditions, the distance will be less. This type of analysis may be useful in estimating ignition exclusion zones. The 328 foot initial isolation zone distance came from the 2004 Emergency Response Guidebook, published by the Department of Transportation, and does not apply here.

The Protective Action Distance can, of course, be based on toxicity and not on the Lower Explosive Distance.
